Utilizing Green Infrastructure to Protect Public Health at Beaches: *A Case Study in Suttons Bay, MI*

Suttons Bay Stormwater Remediation

Project Overview:

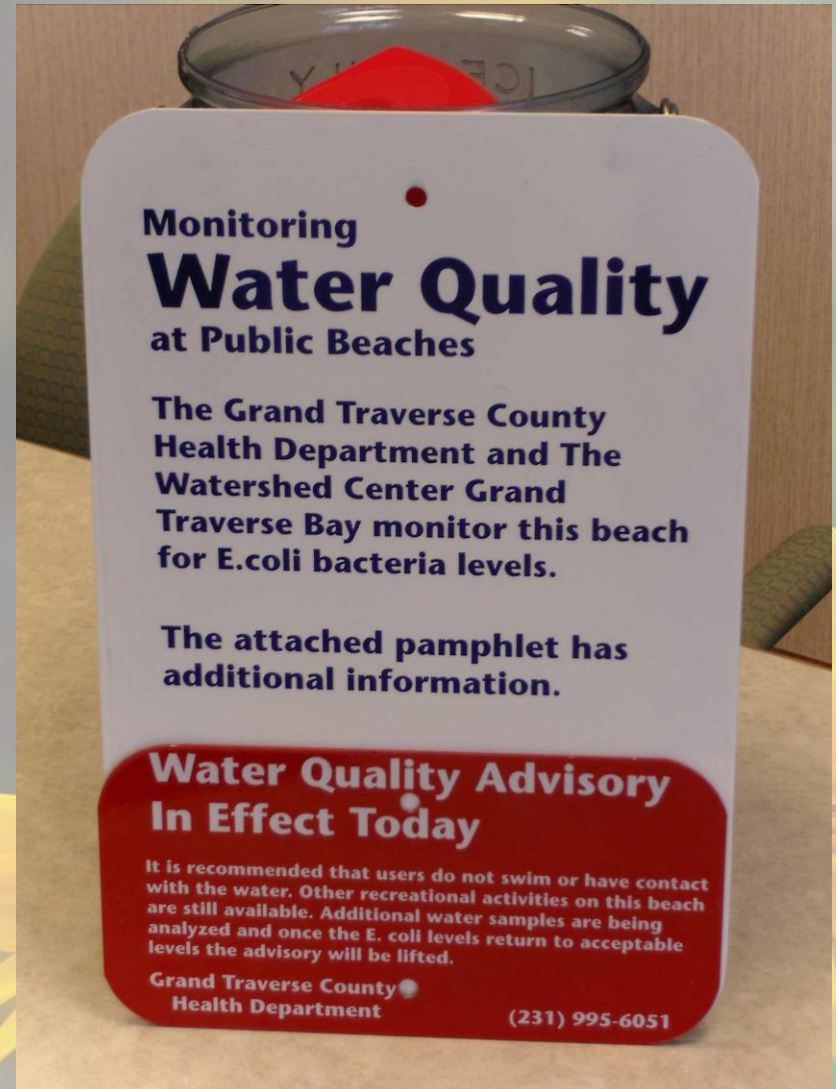
Water quality monitoring sign for GT County beach

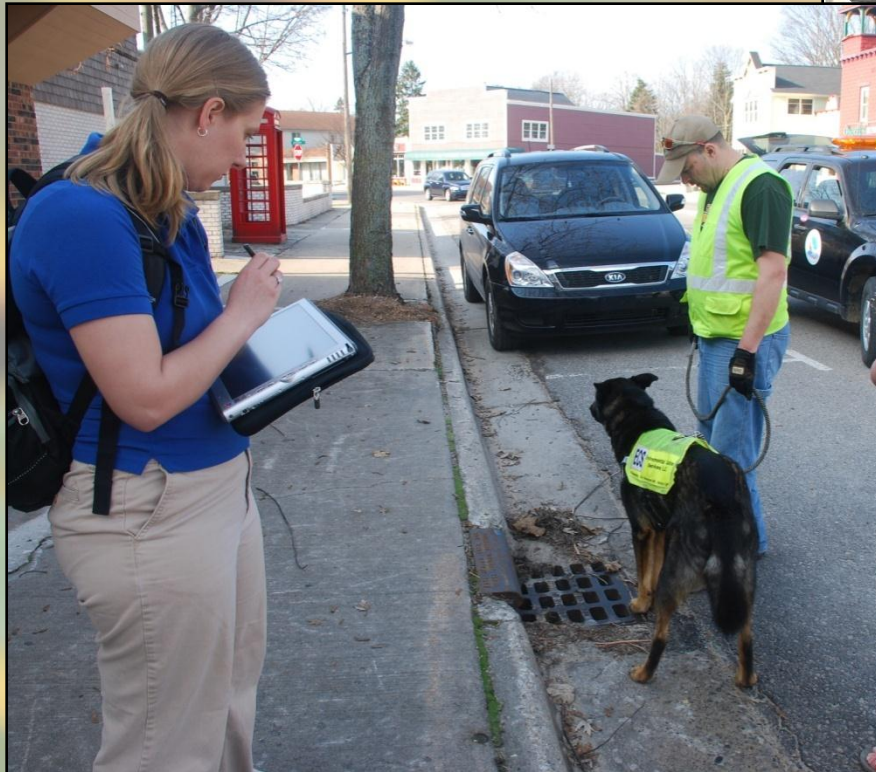
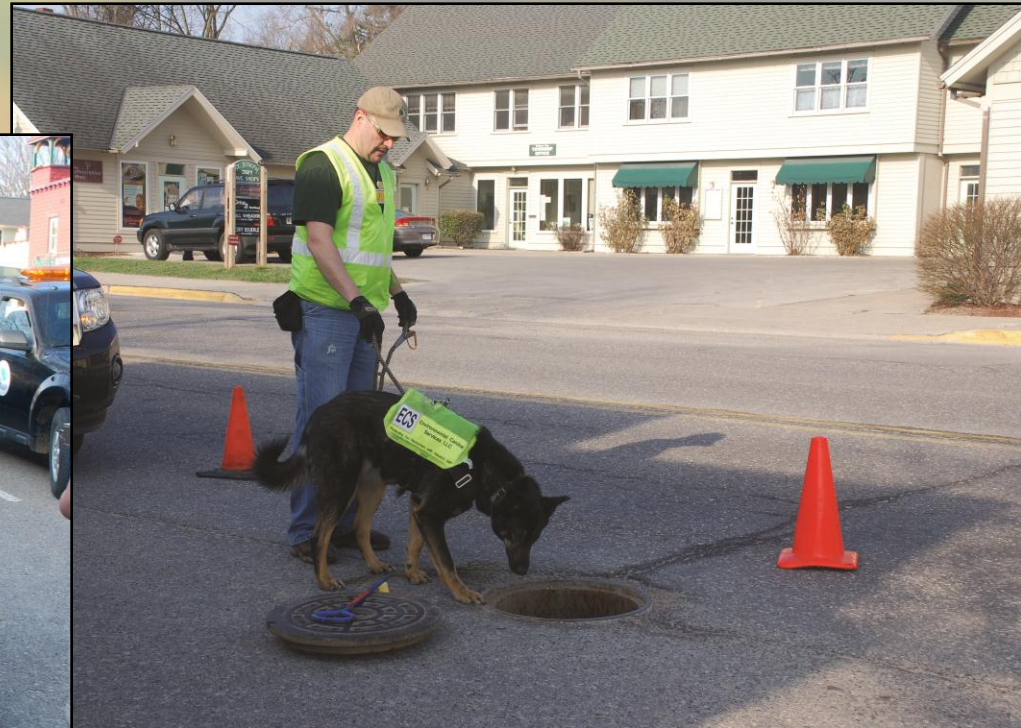
Environmental Canine Services (Scott and canine Sable) inspect storm drains in Suttons Bay, looking for human sourced bacteria

- Utilized canine unit trained to detect human sewage
- No 'hits' = no human sources of E.Coli
- Quickly verified E.Coli levels are animal sourced rather than human sourced
- Developed BMPs accordingly

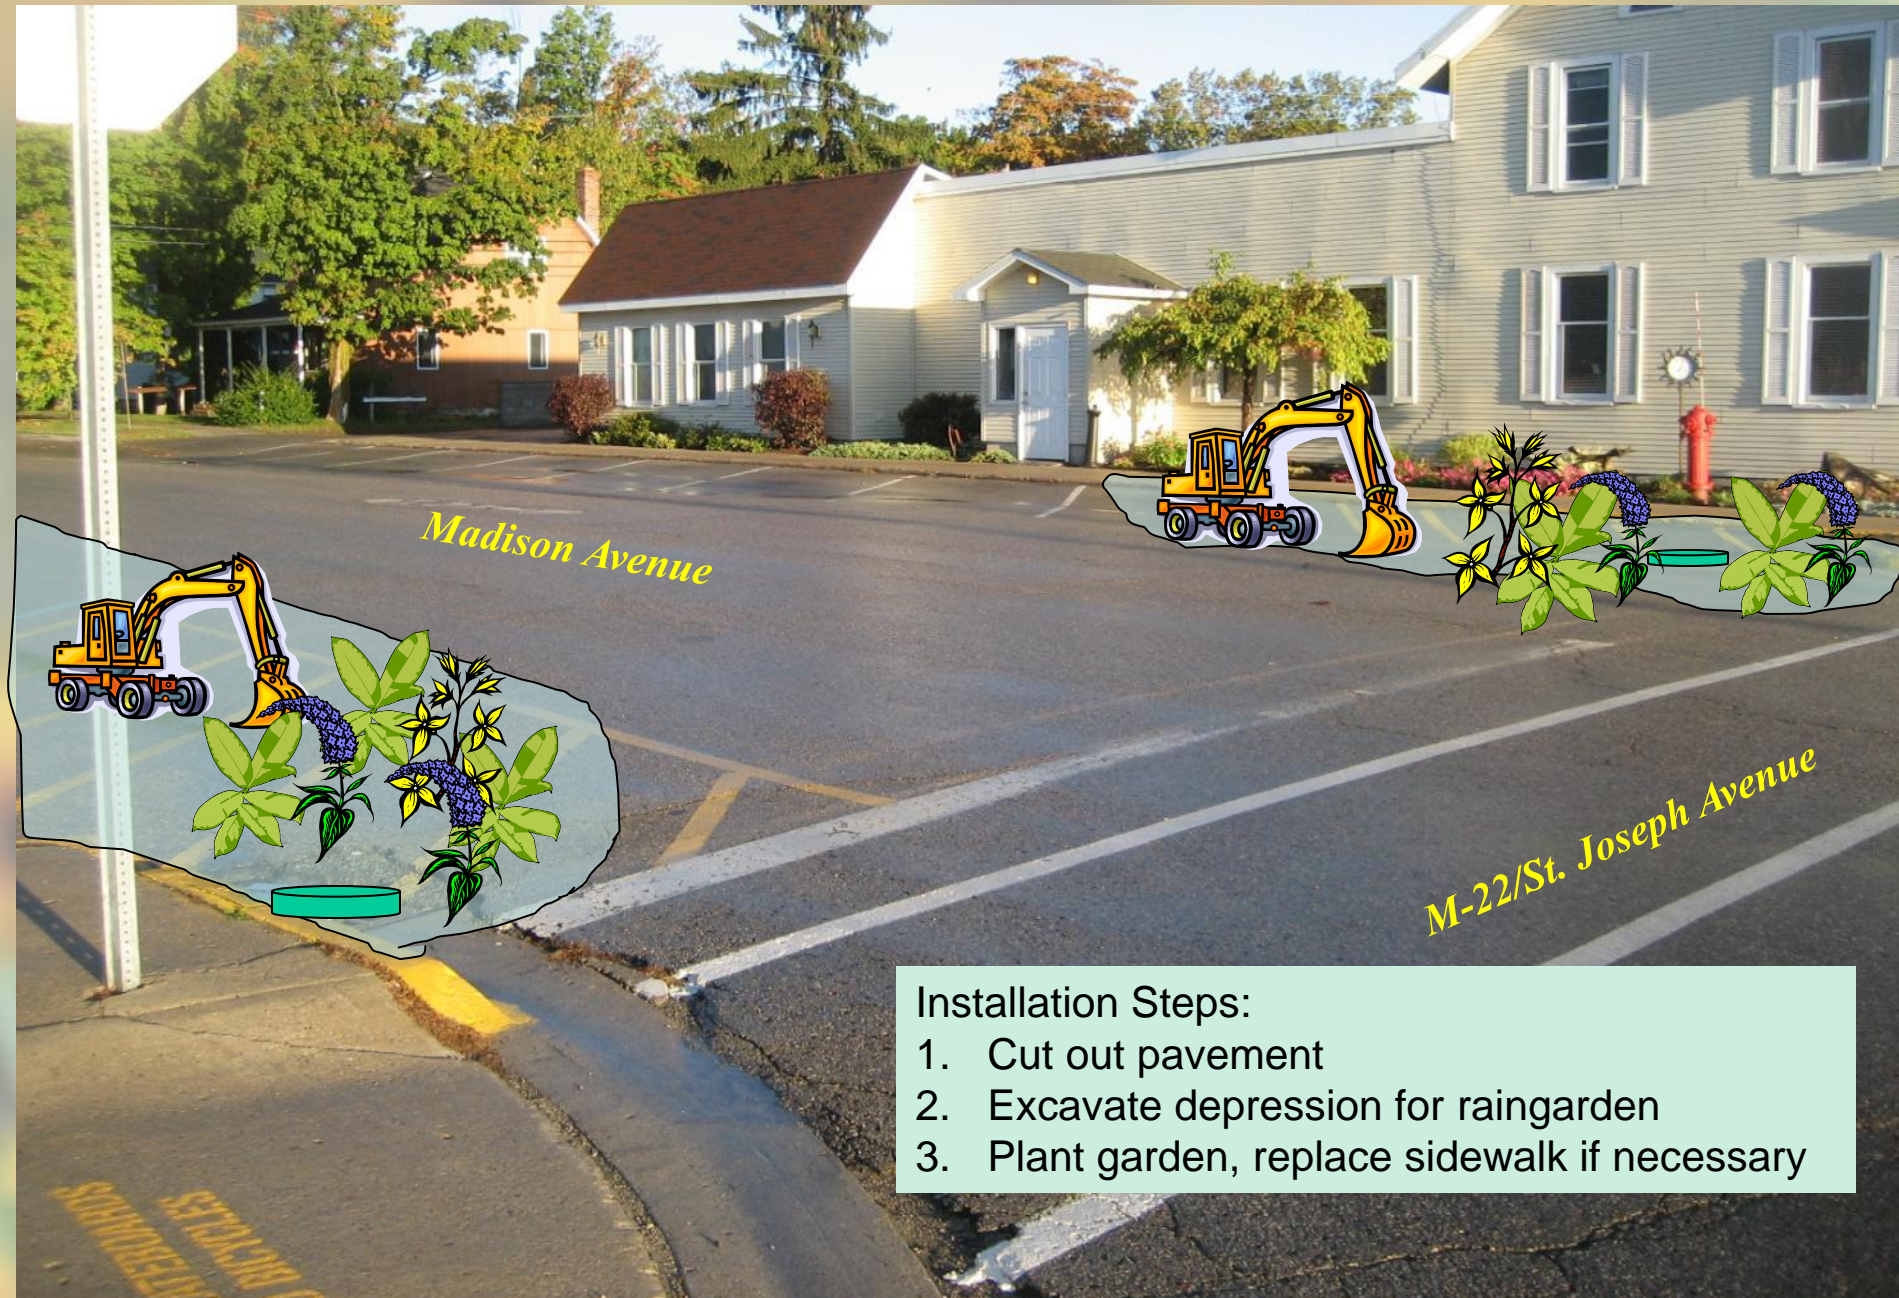
Installation Steps:

1. Cut out pavement
2. Excavate depression for raingarden
3. Plant garden, replace sidewalk if necessary

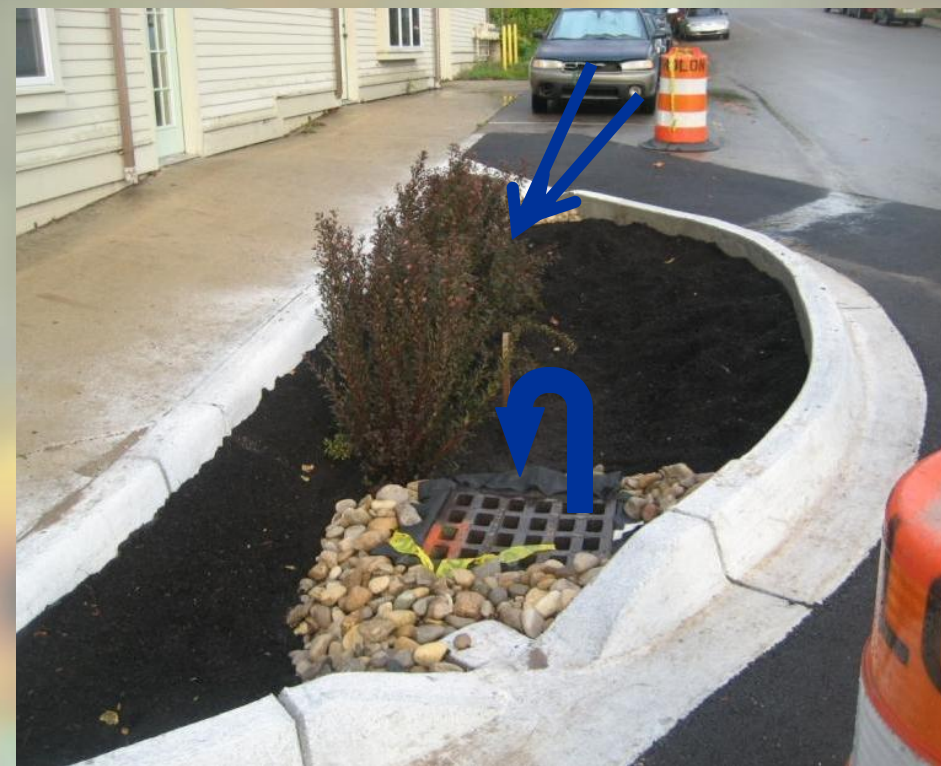
Southwest corner of Adams St and St. Joseph Ave (M-22)

Treatment Steps:

1. Runoff enters garden, fills depression, and infiltrates naturally to ground
2. Excess water spills into the storm system inlet
3. Will eventually make its way to infiltration trench (discussed later)

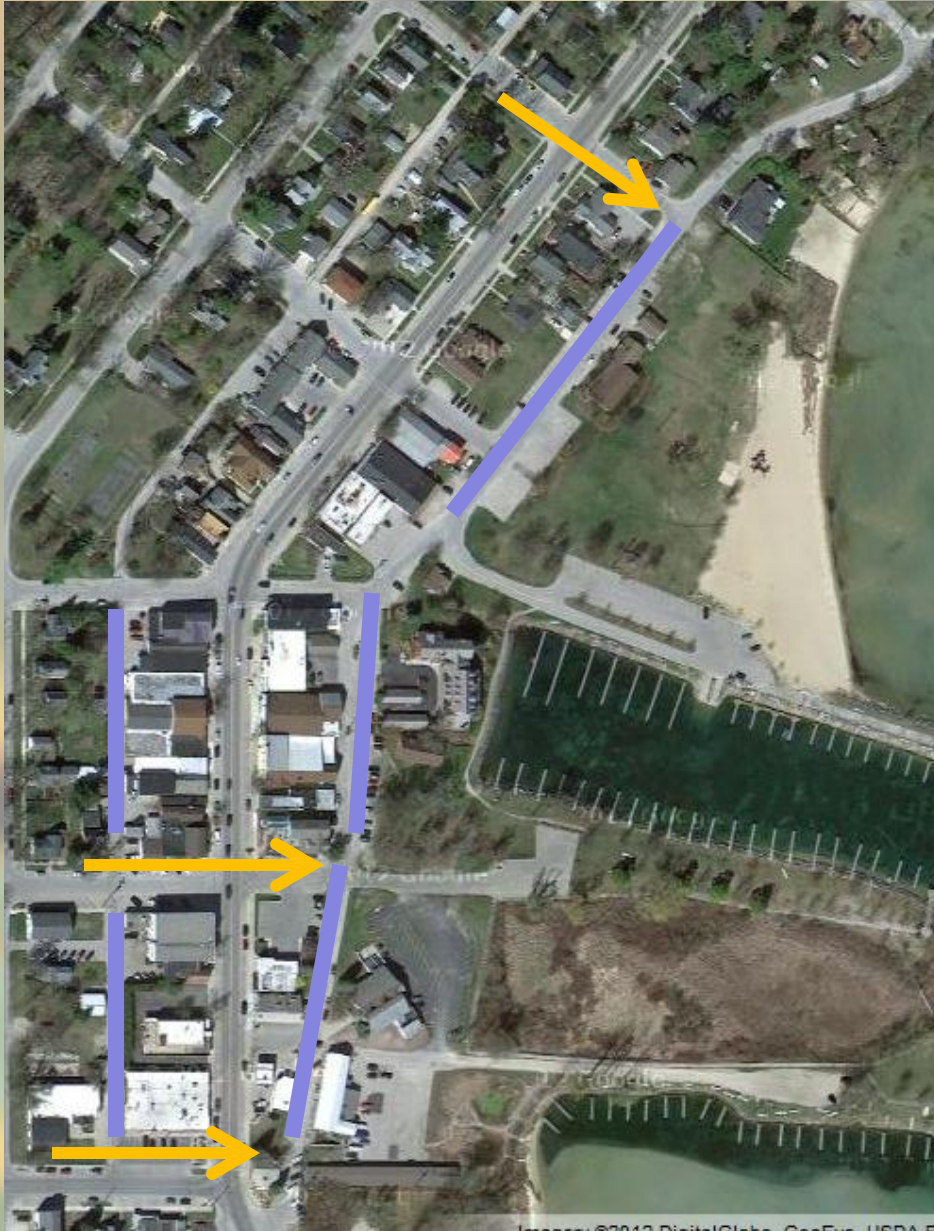
Where:

- Alleys: Broadway-Madison Ave, Madison-Jefferson Ave
- Front Street: Broadway-Jefferson, Grove-Adams Street

**About 3,612 feet of
infiltration trench installed
~nearly $\frac{3}{4}$ mile**

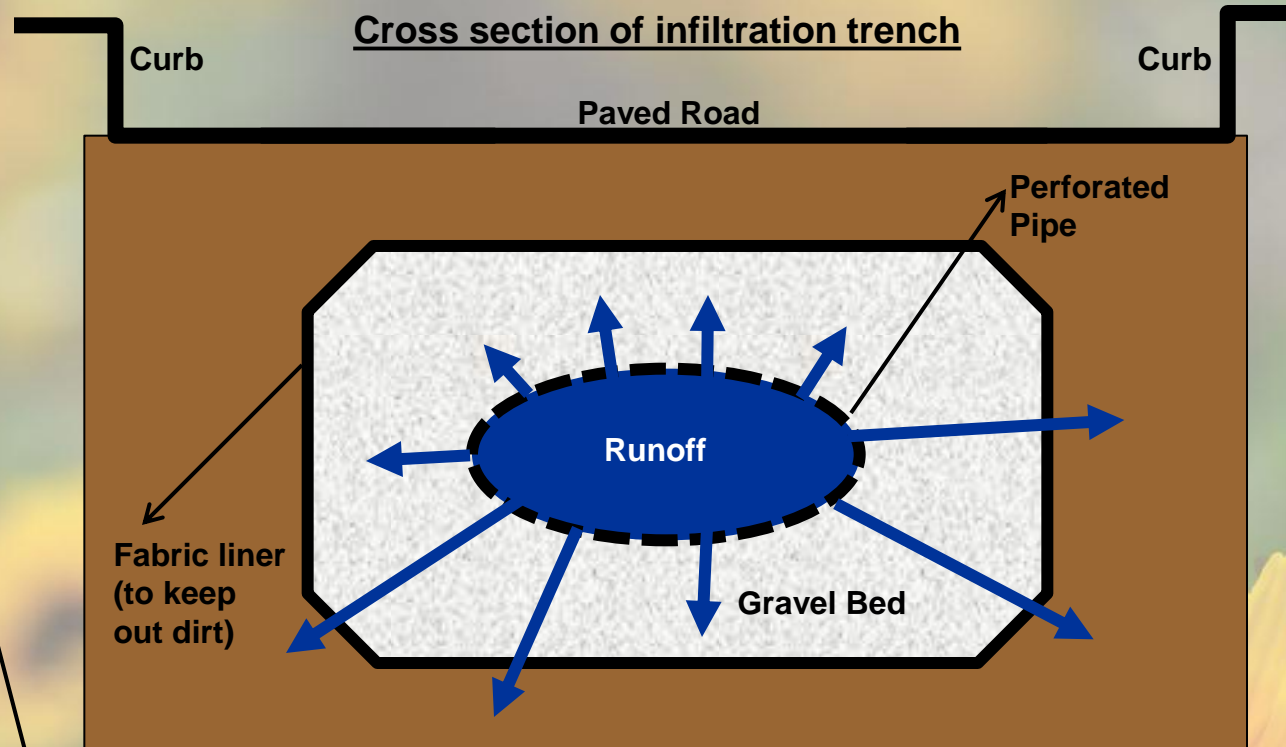
1. Diversion wier directs flow to system from existing storm drain system (including water from overflow of rain gardens)
2. Pretreatment for trash, sediments via Oil/grit separator
3. Trenches fill up and infiltrate to ground, perforated pipe buried in gravel (see figure at right)
4. Overflow back to existing drain system

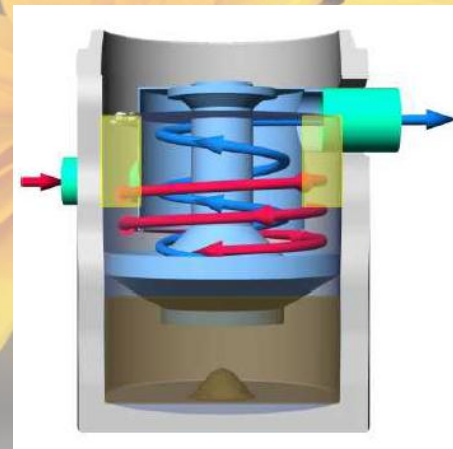
Pretreatment of trash and sediments provided by oil/grit separator

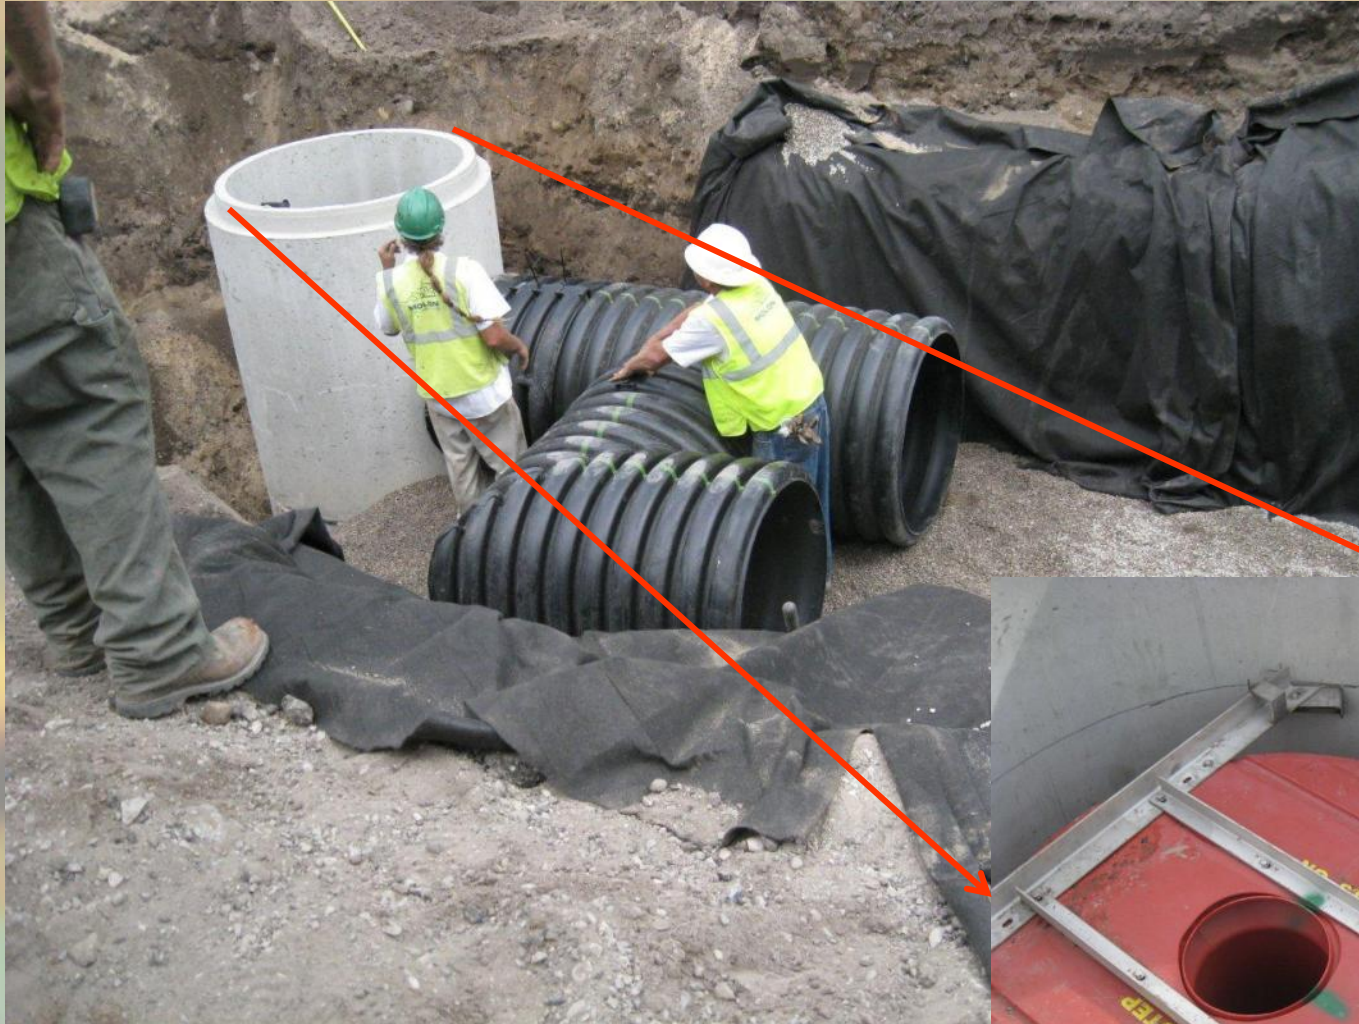
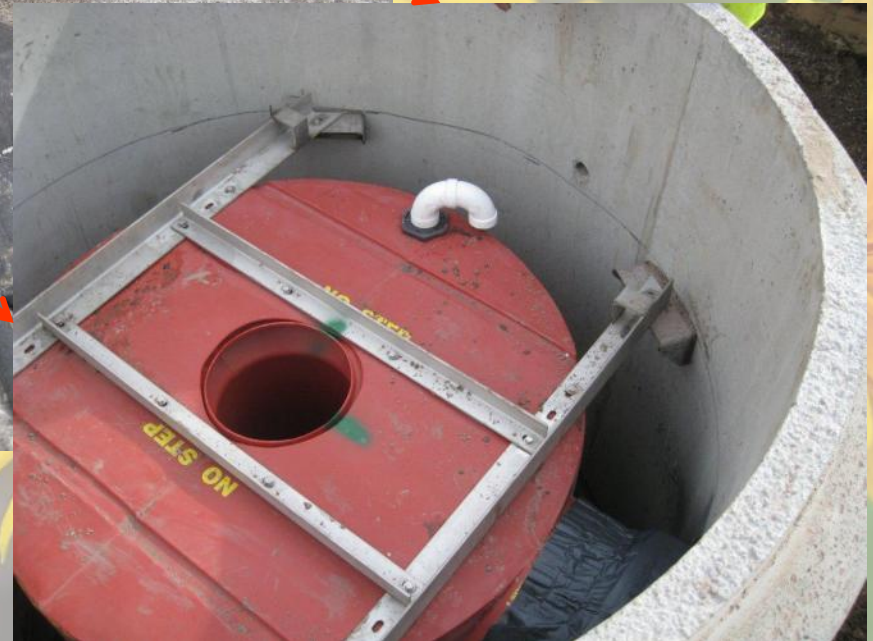
**Above: Trench Installation – note
gravel bed and size of tubes
Right: Oil/grit separator**

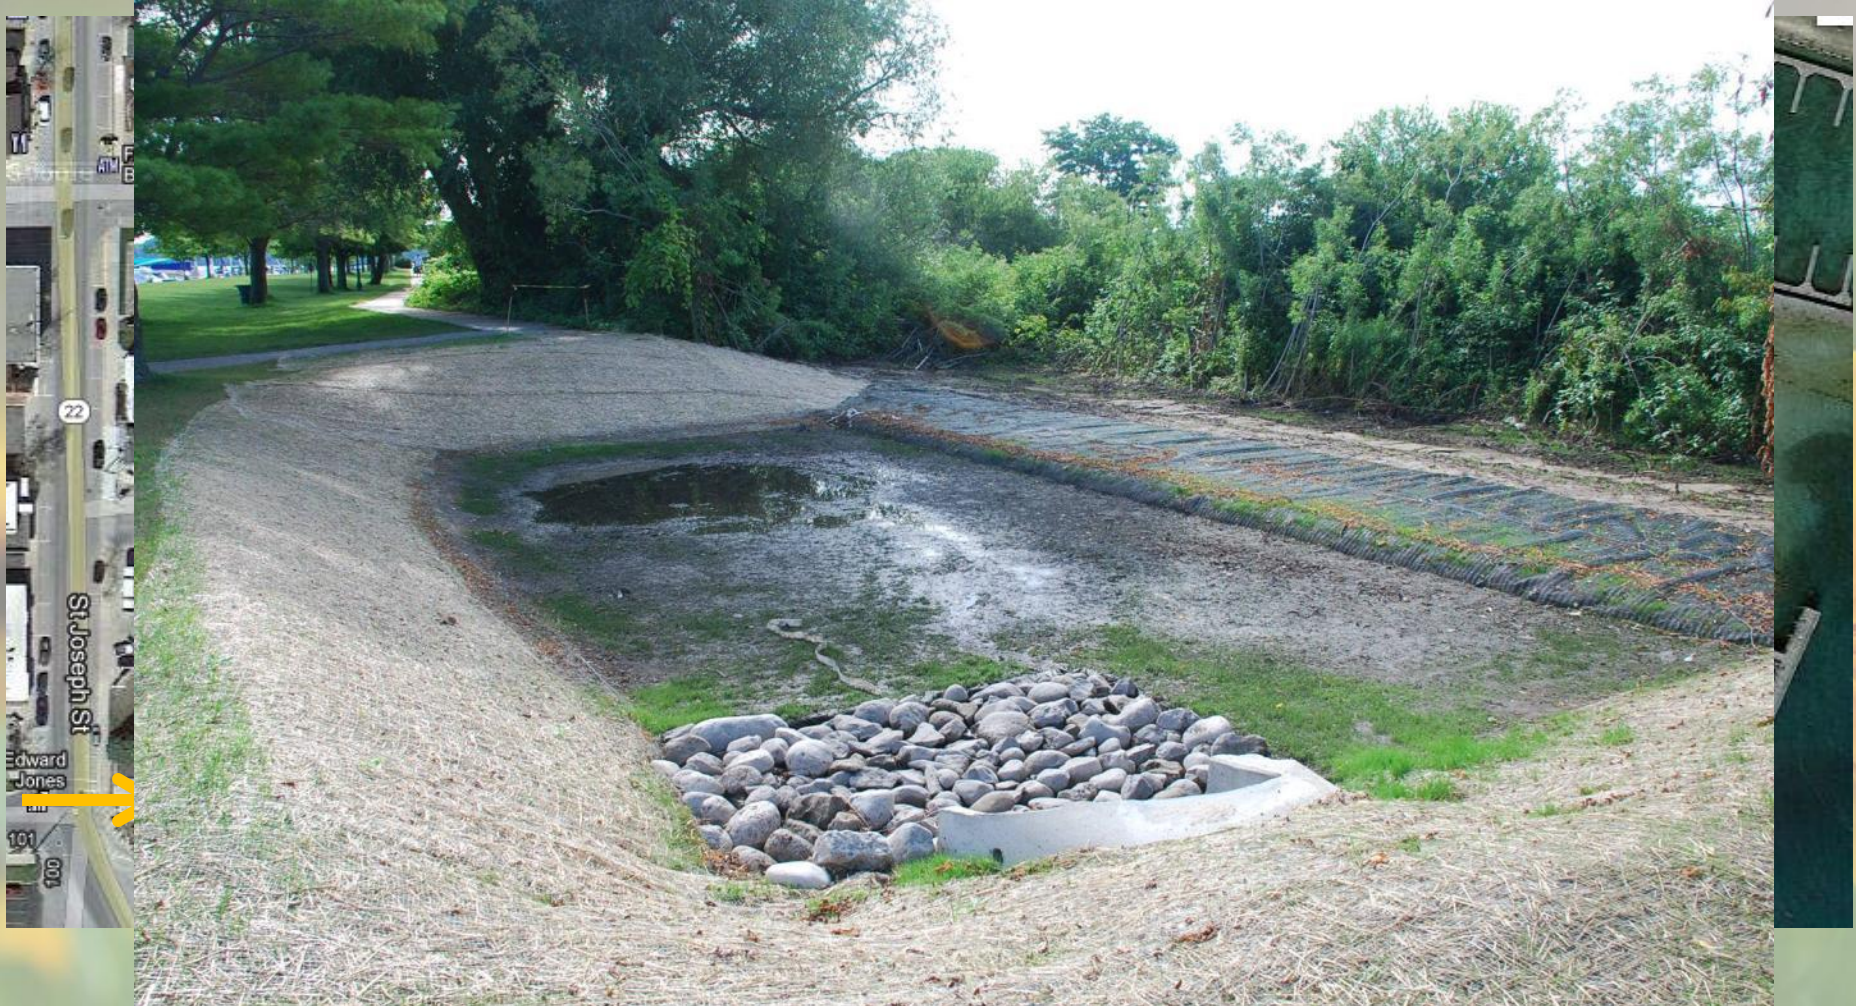
- Madison outlet abandoned and redirected to wetland between marina and south docks
- Most flow to Broadway line into infiltration trench, overflow split between current outlet and wetland

New drain outlet at the end of Madison adjacent to existing wetland

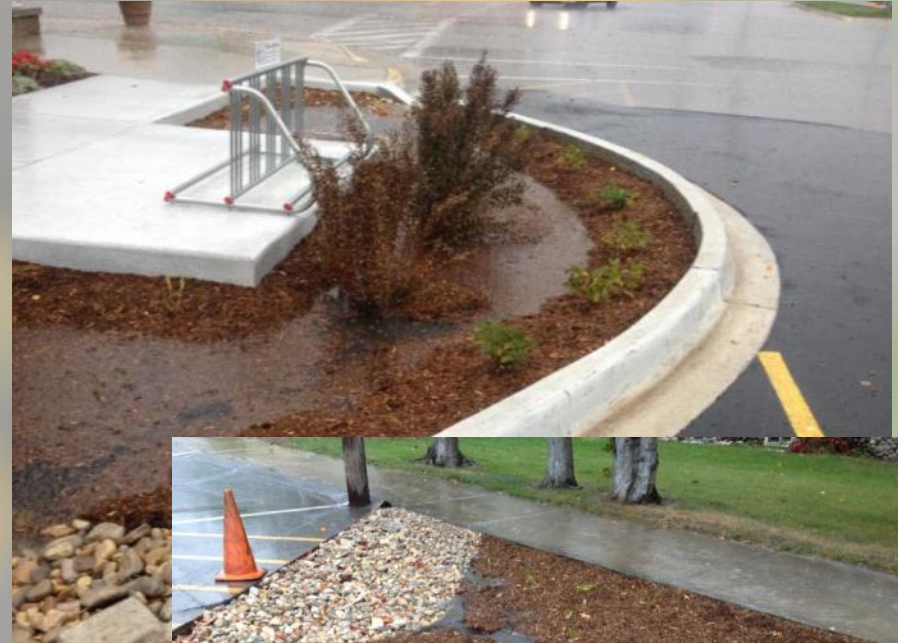
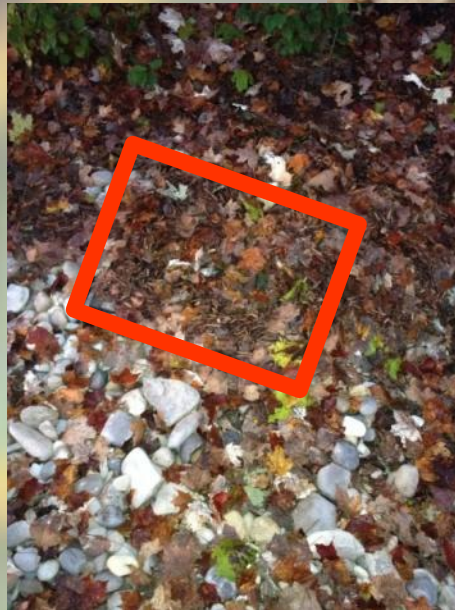
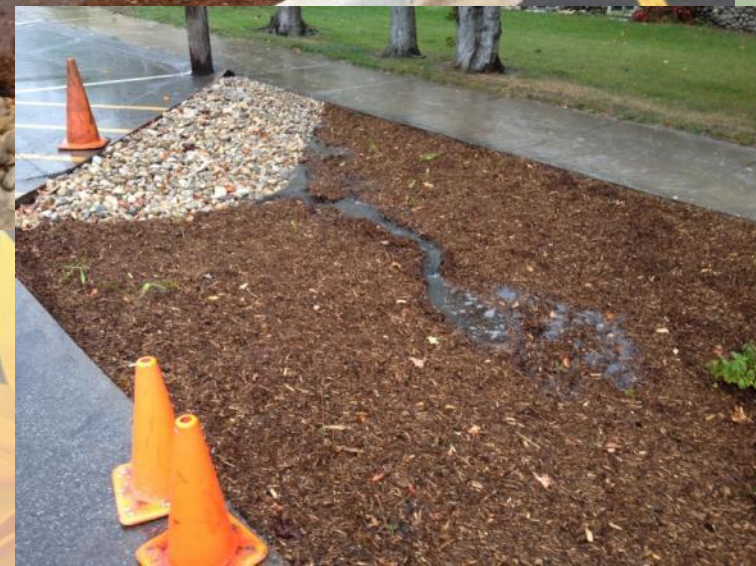
Above: Note floating mulch, gullies in newly planted gardens
Left: Mulch and leaves blocking overflow inlet to drain system

- Rain Gardens
 - ✓ Watch closely the first few weeks, note where water is coming in and look for erosion
 - ✓ Mulch will float until a mat forms, some will be transported into pipe
 - ✓ Clean storm inlets regularly, leaves will clog
 - ✓ Rocks will be helpful around inlets to rain garden and storm drains
 - ✓ Spring clean-up necessary – blow/rake out excess sand, grit, and leaves
 - ✓ Public prefers rain gardens with curbing

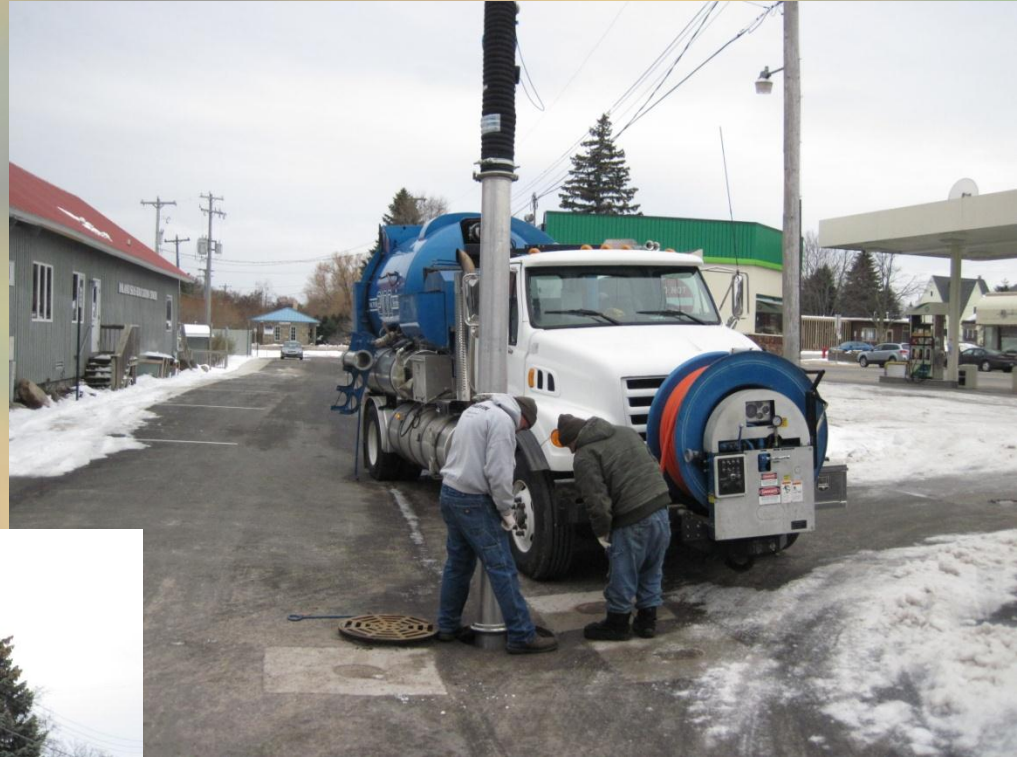
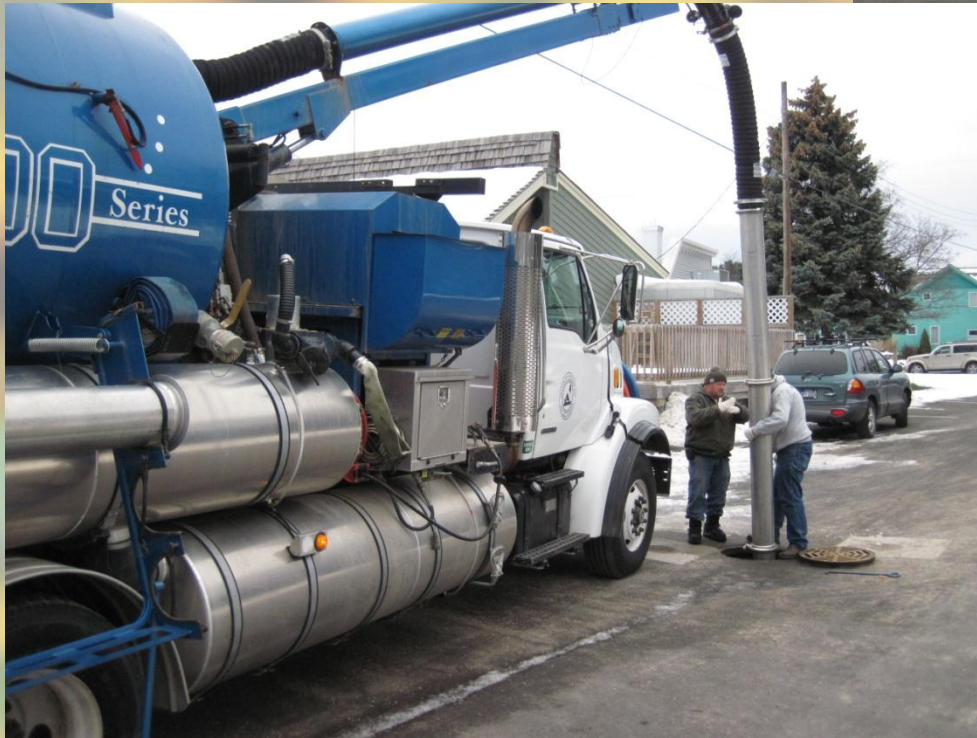
Above and Left: Village of Suttons Bay Public Works employees clean out oil/grit separators early Winter (after heavy Fall rains)

- Infiltration Trenches
 - ✓ Oil grit separators must be cleaned periodically
 - ✓ Trenches must be power washed and vacuumed out at least yearly
